# ESS Emergencies

*Anthony Natale ConEdison*

# APS Incident

McMicken Substation

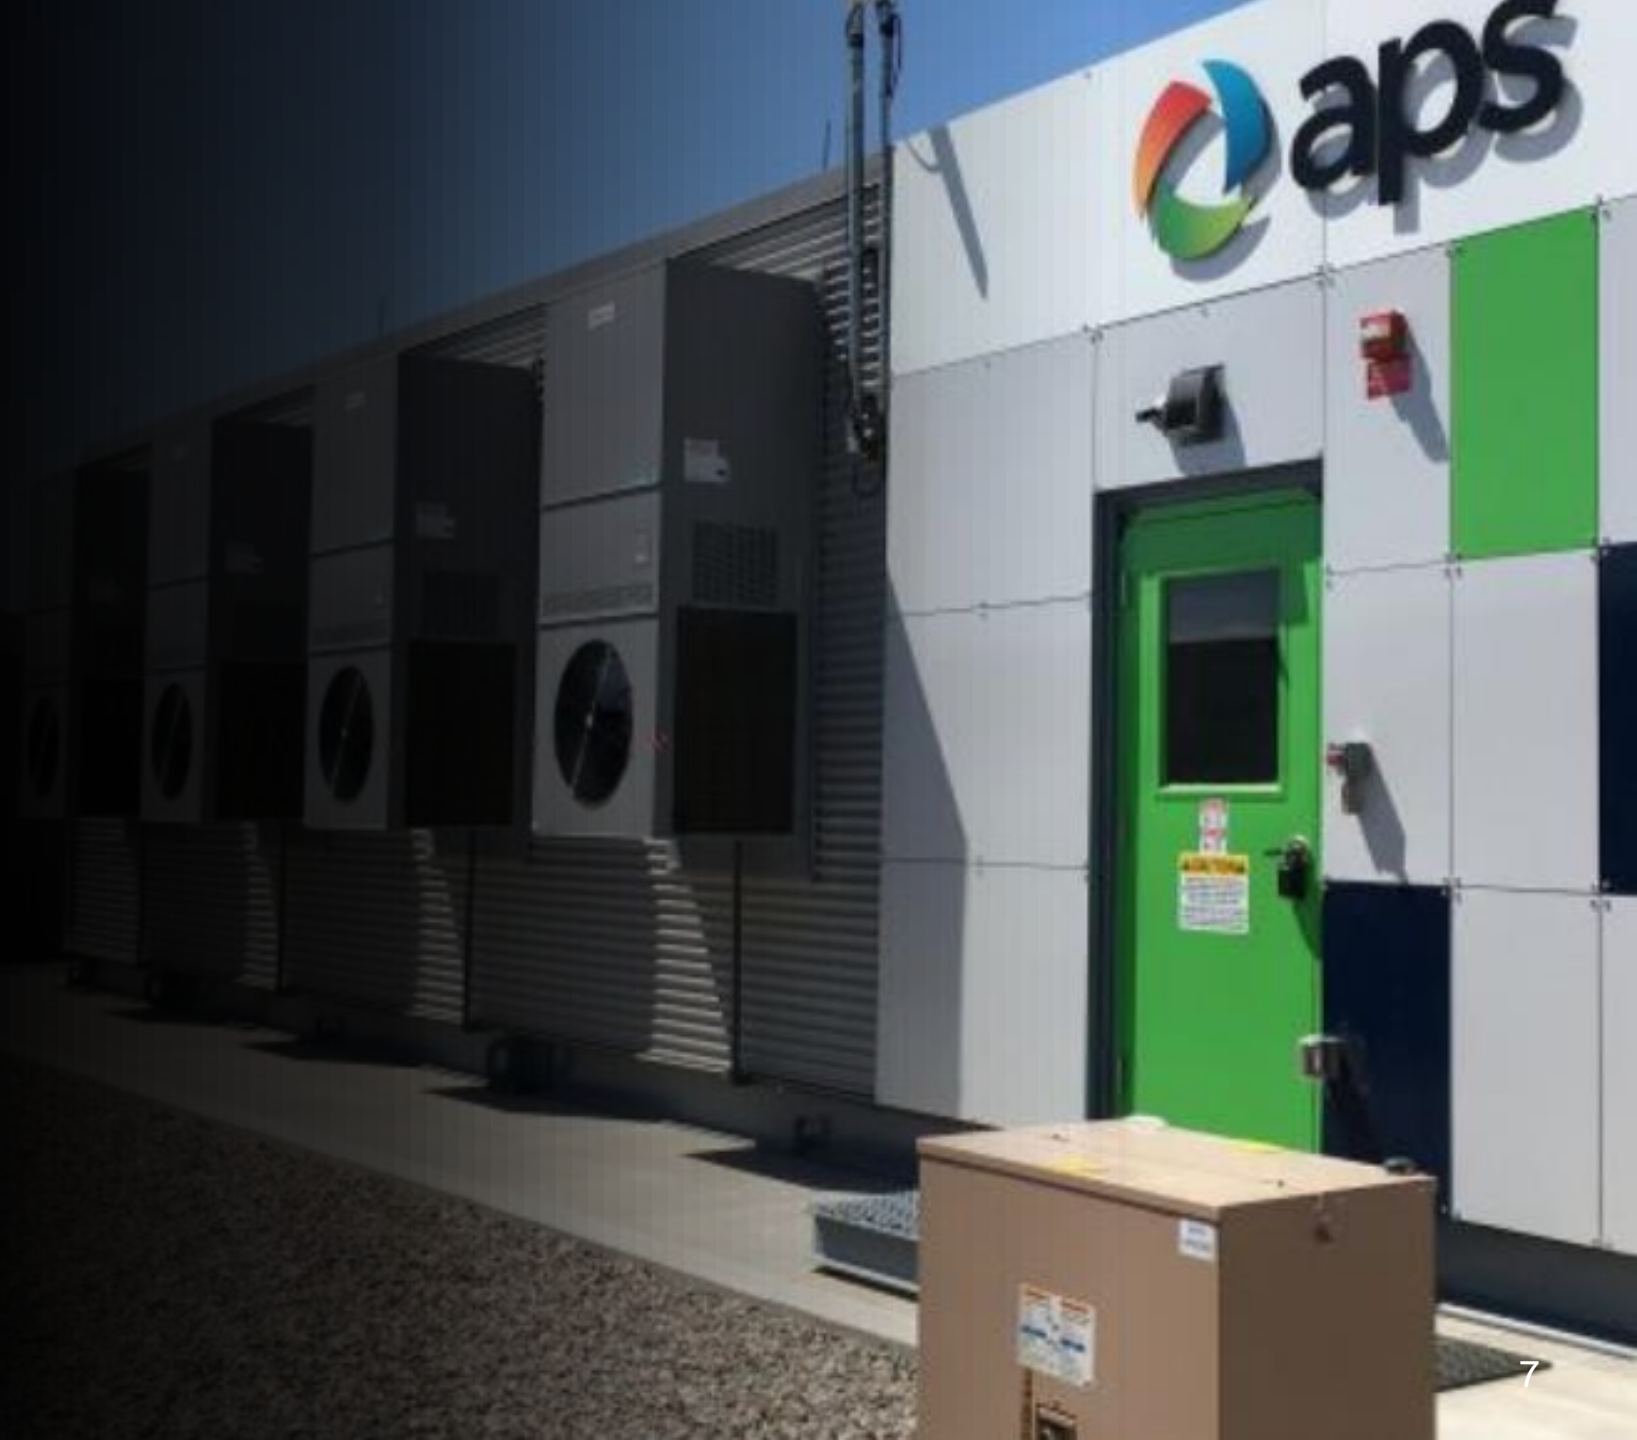
- 378 LI Modules – LG Chem
- 8 HVAC Units
- Smoke Detection
- NOVEC 1230 Clean Agent
- No Sprinkler
- No Ventilation System
- No Deflagration Venting
- In Service Two Years

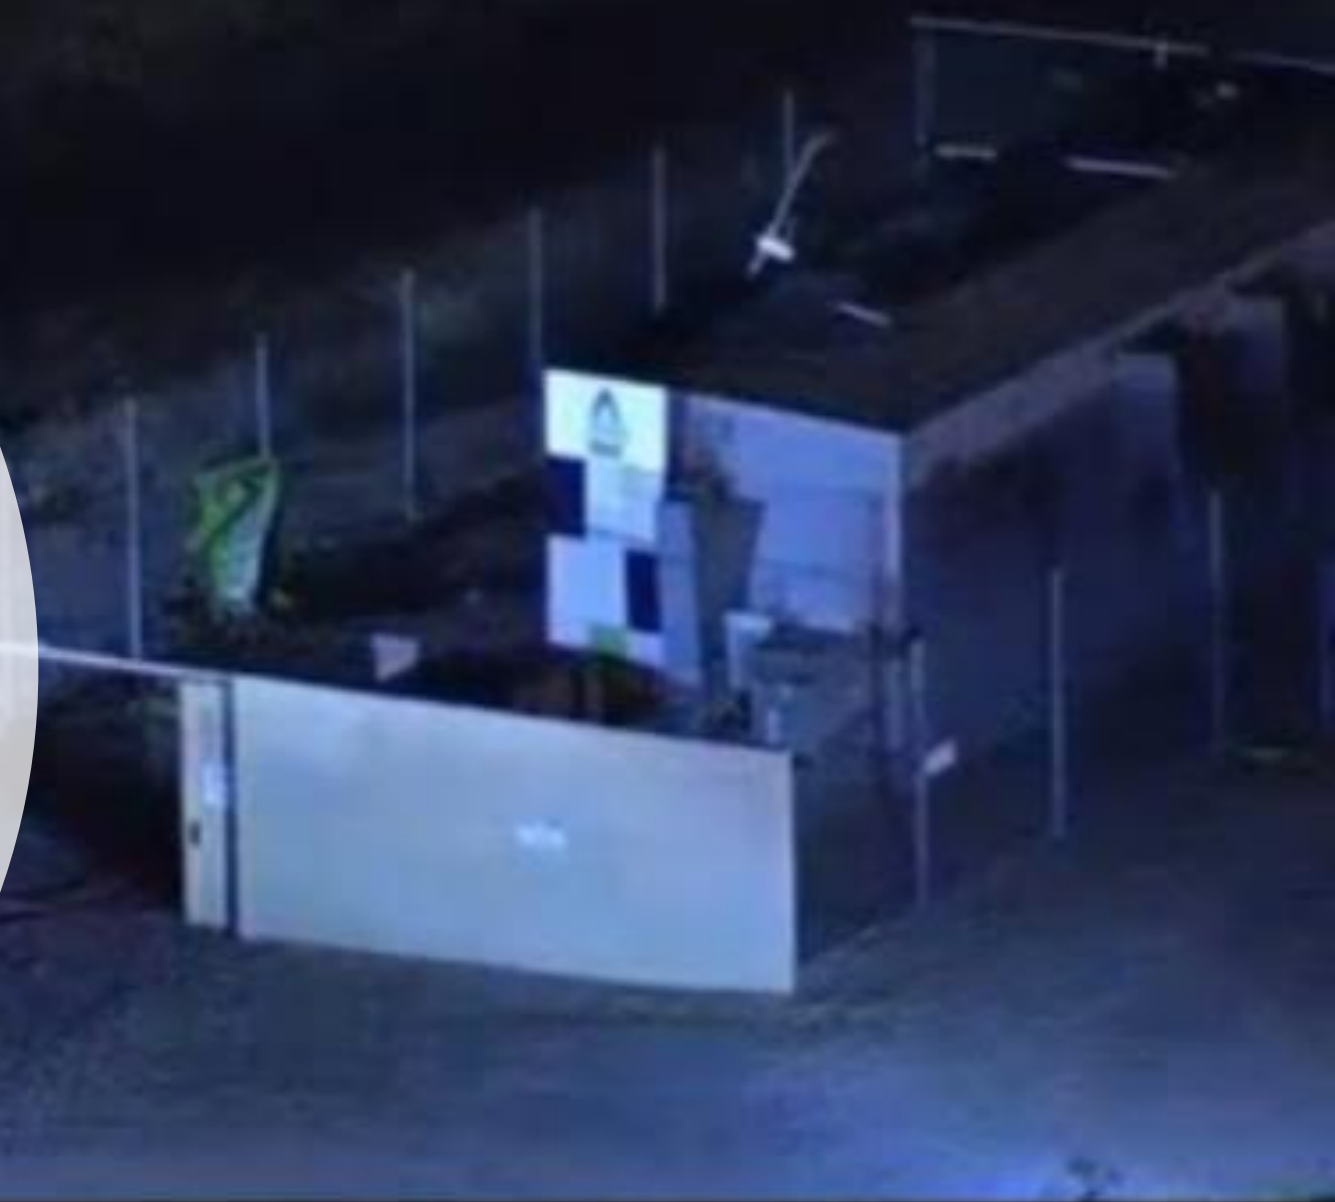
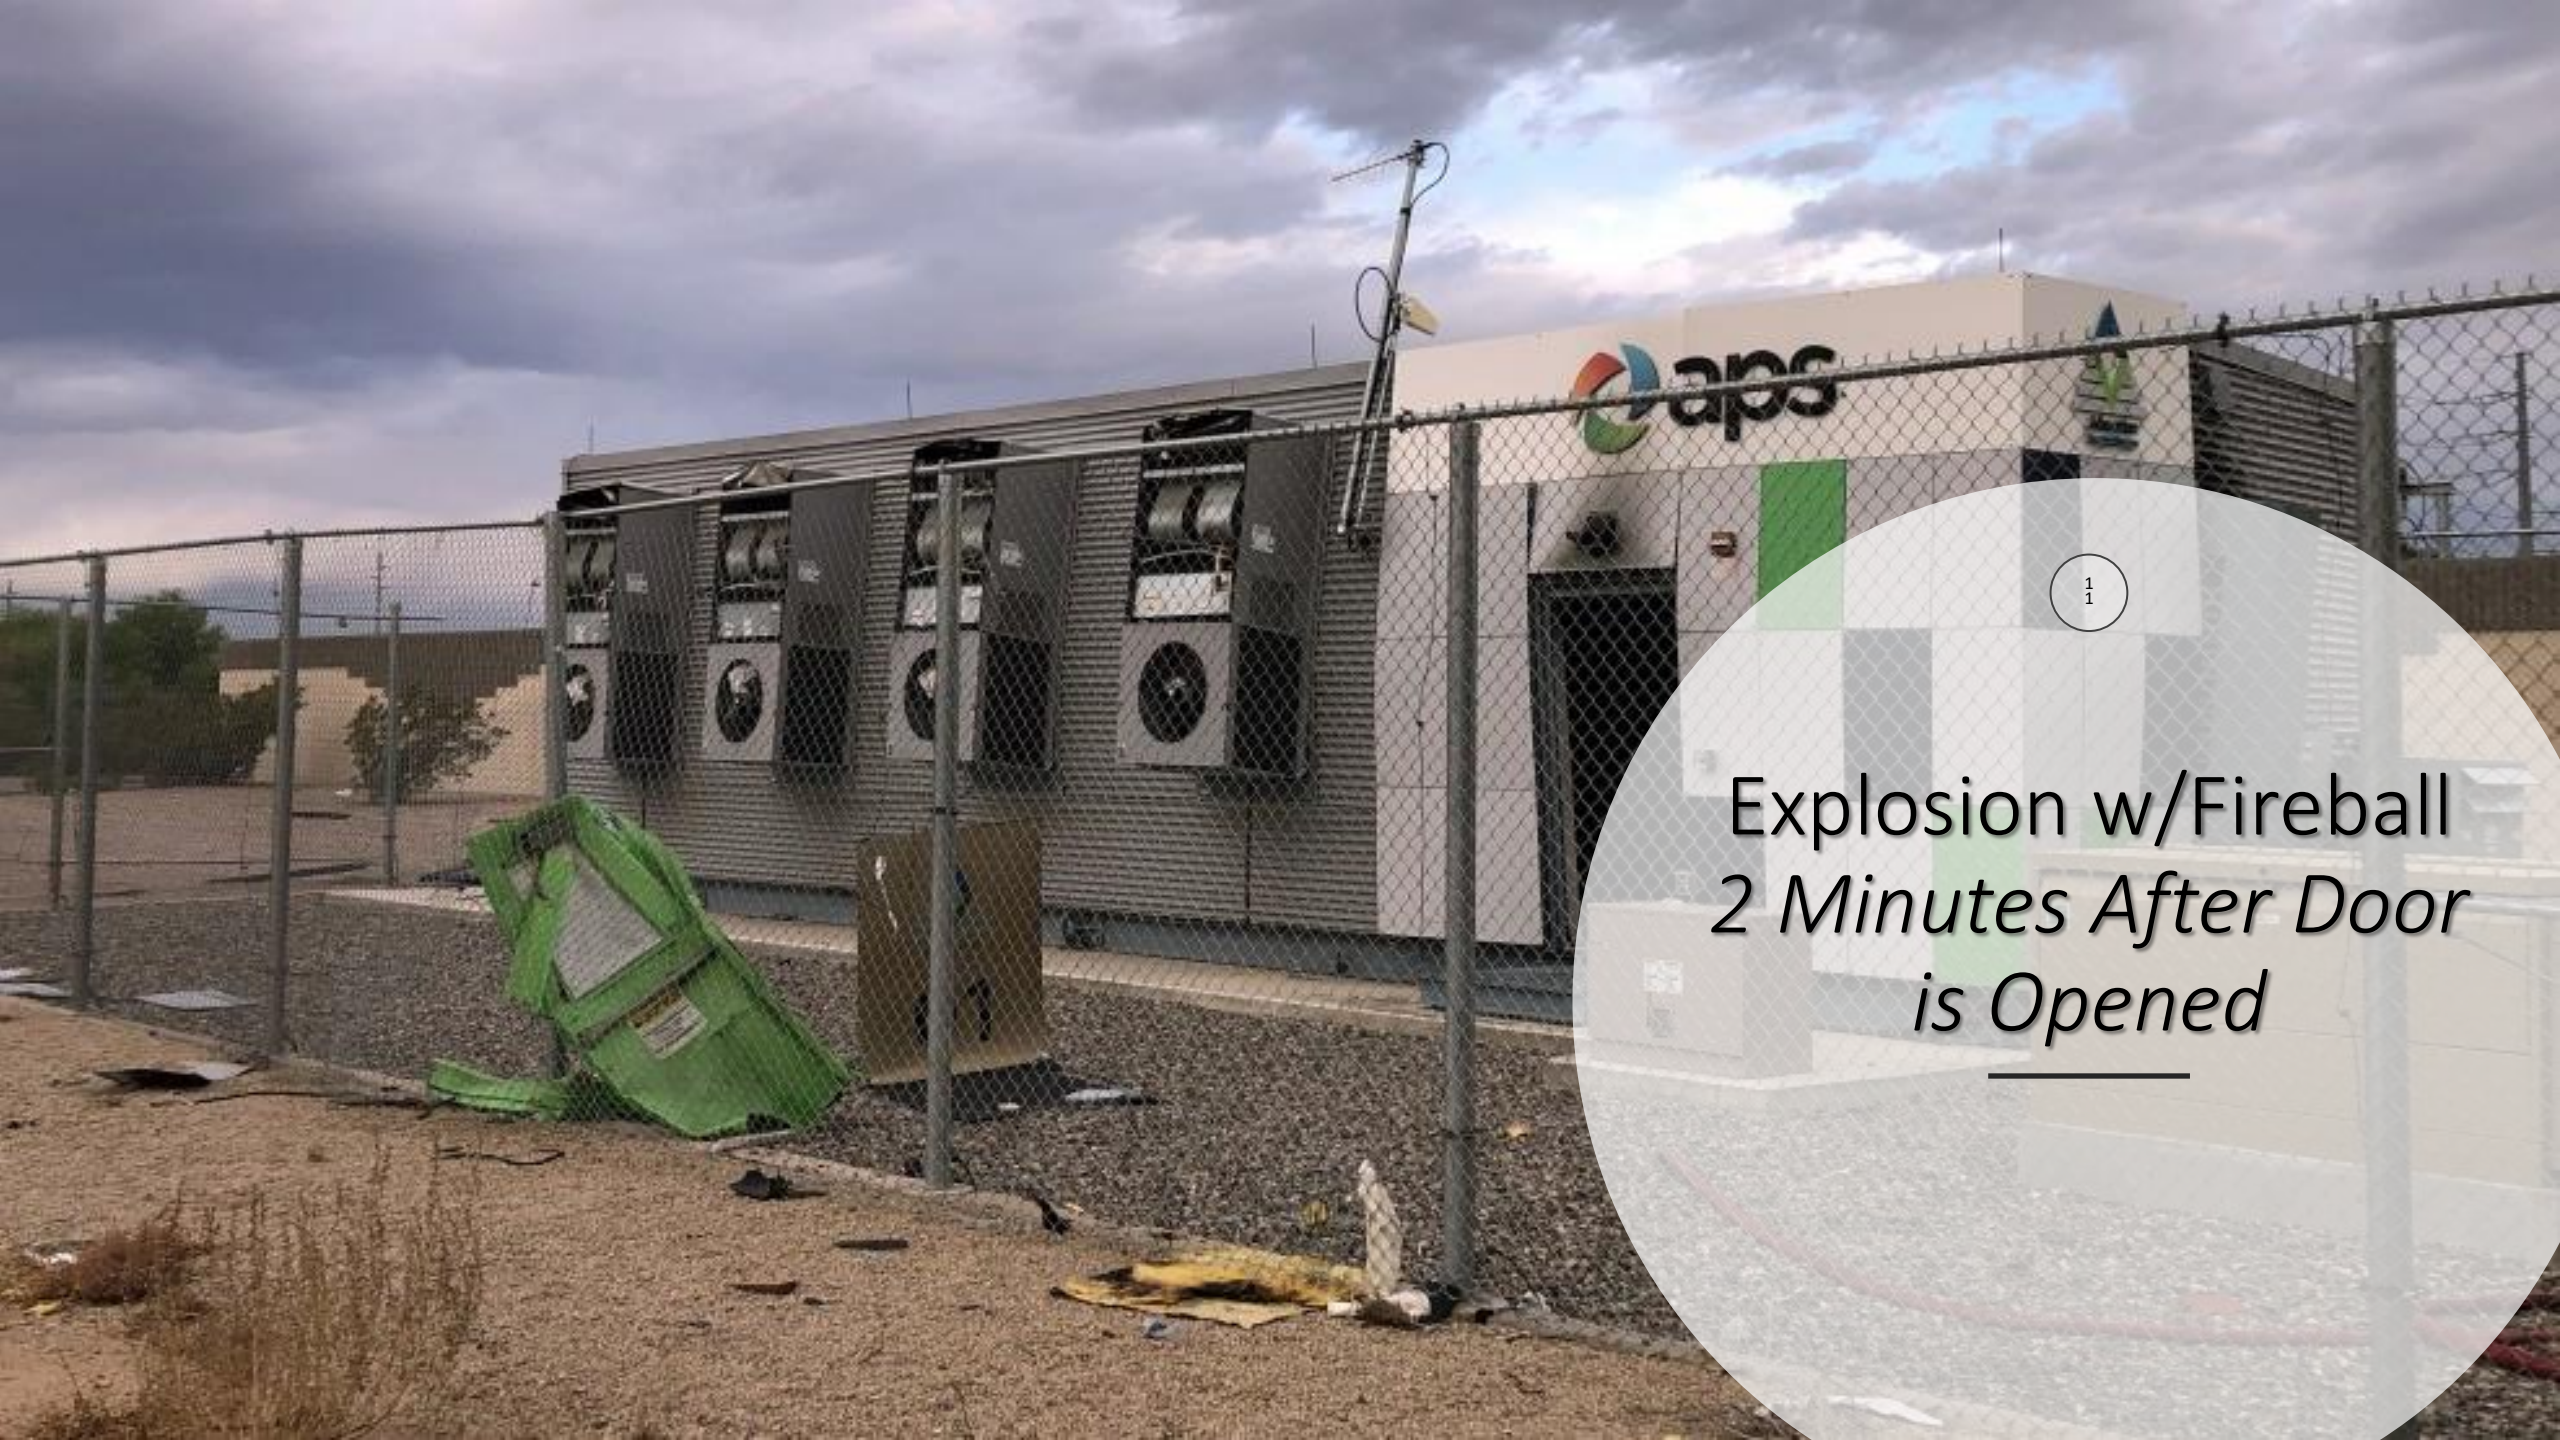
# ESS Door is Opened

- Clean Agent has Discharged
- White Vapor Cloud Hugs Floor
- Consistent Flow
- No Internal TIC Readings
- Flammable Gas Detected

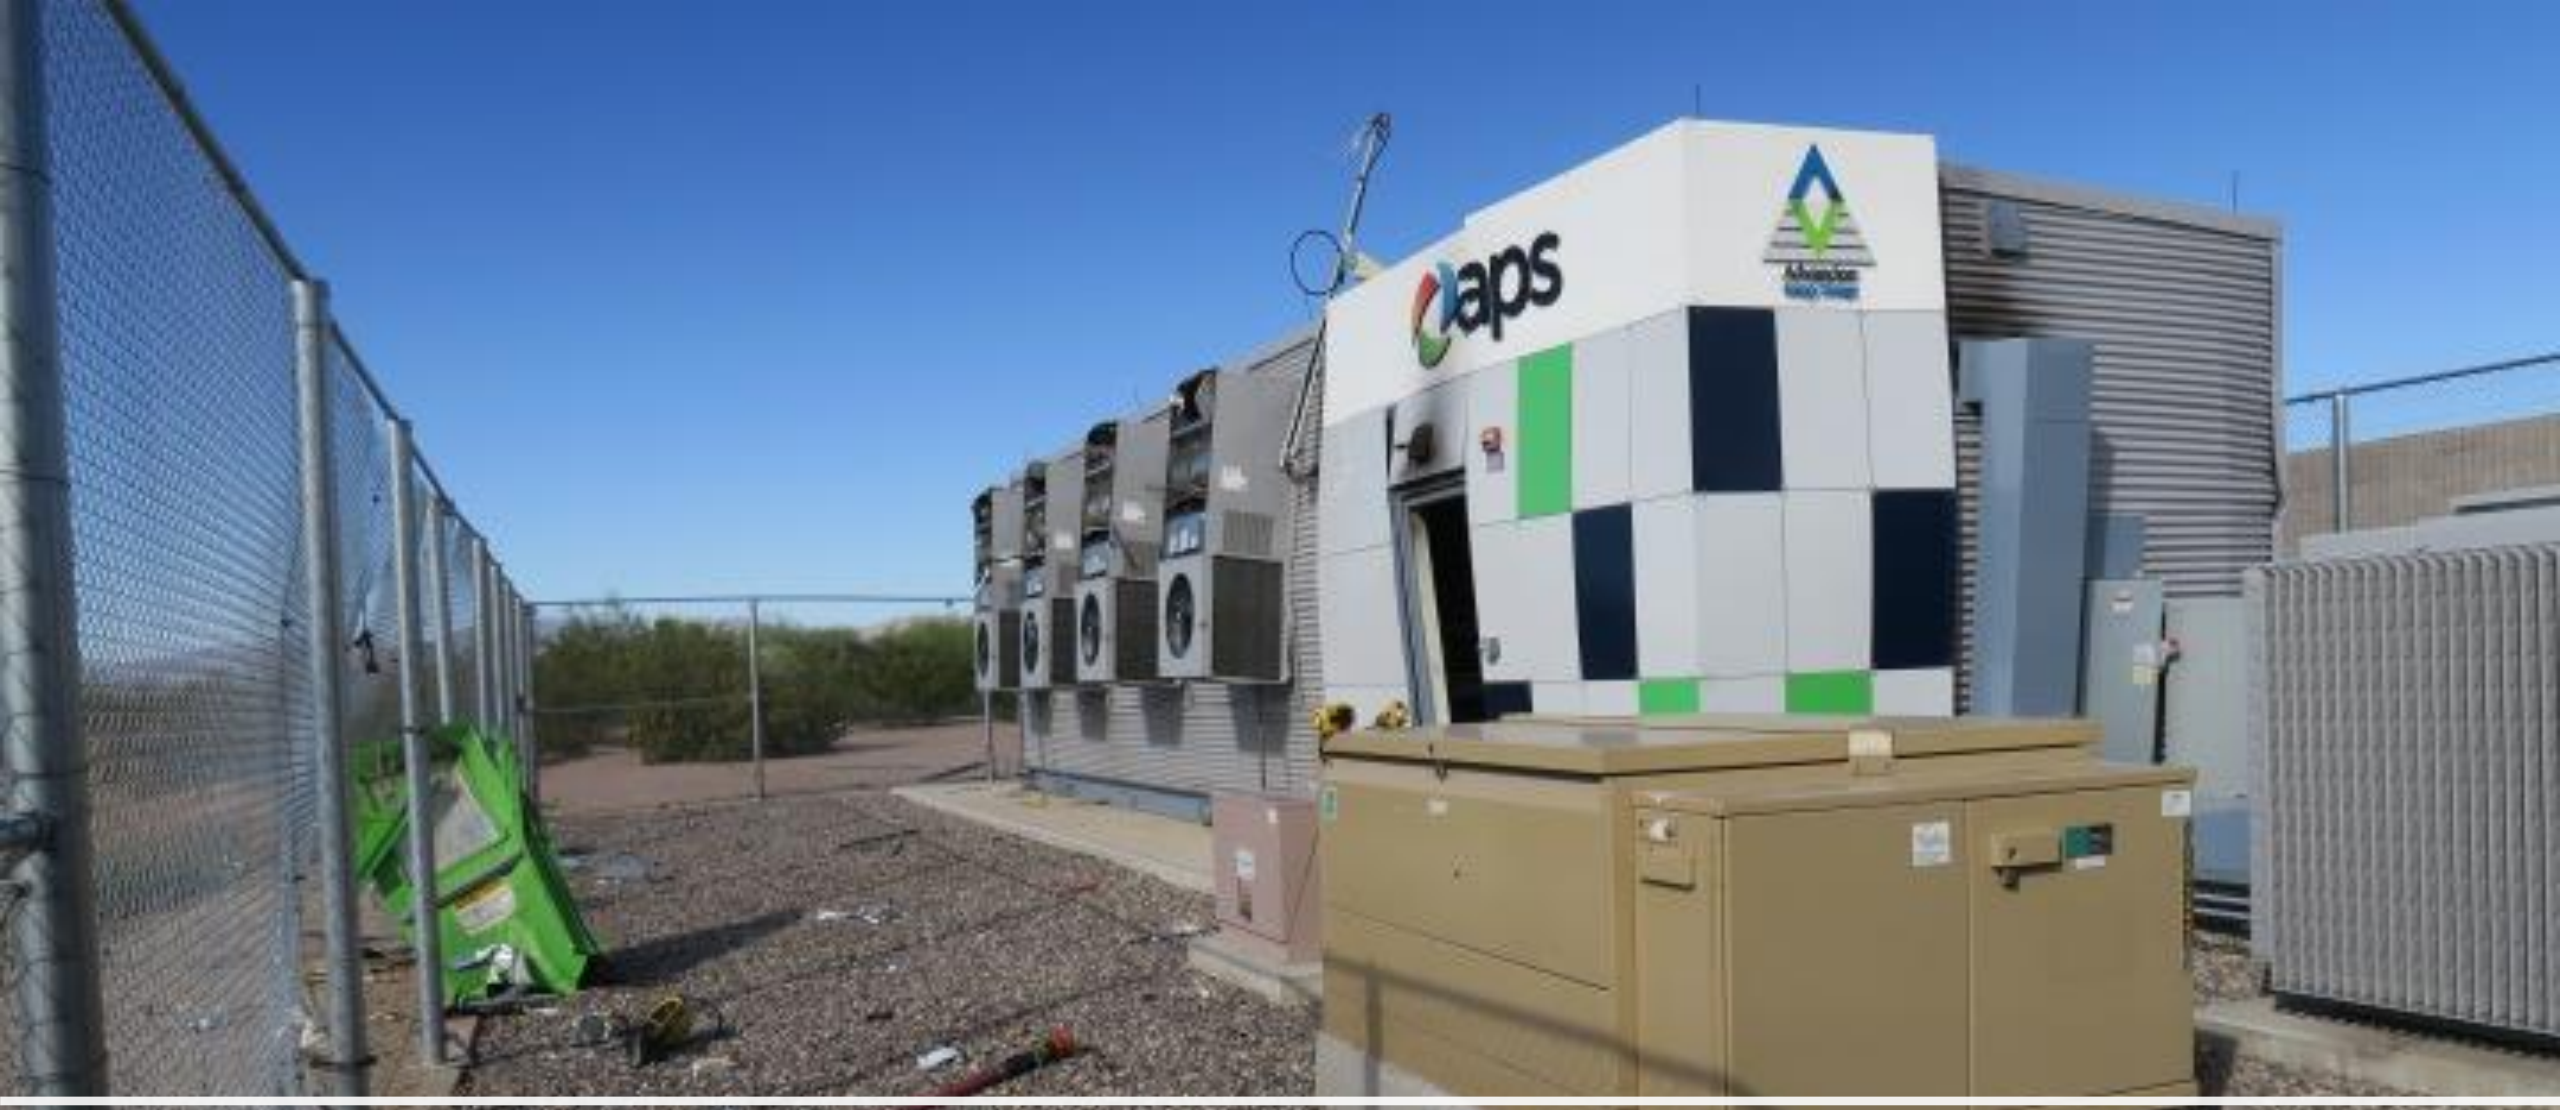
*Explosion w/Fireball  
2 Minutes After Door  
is Opened*

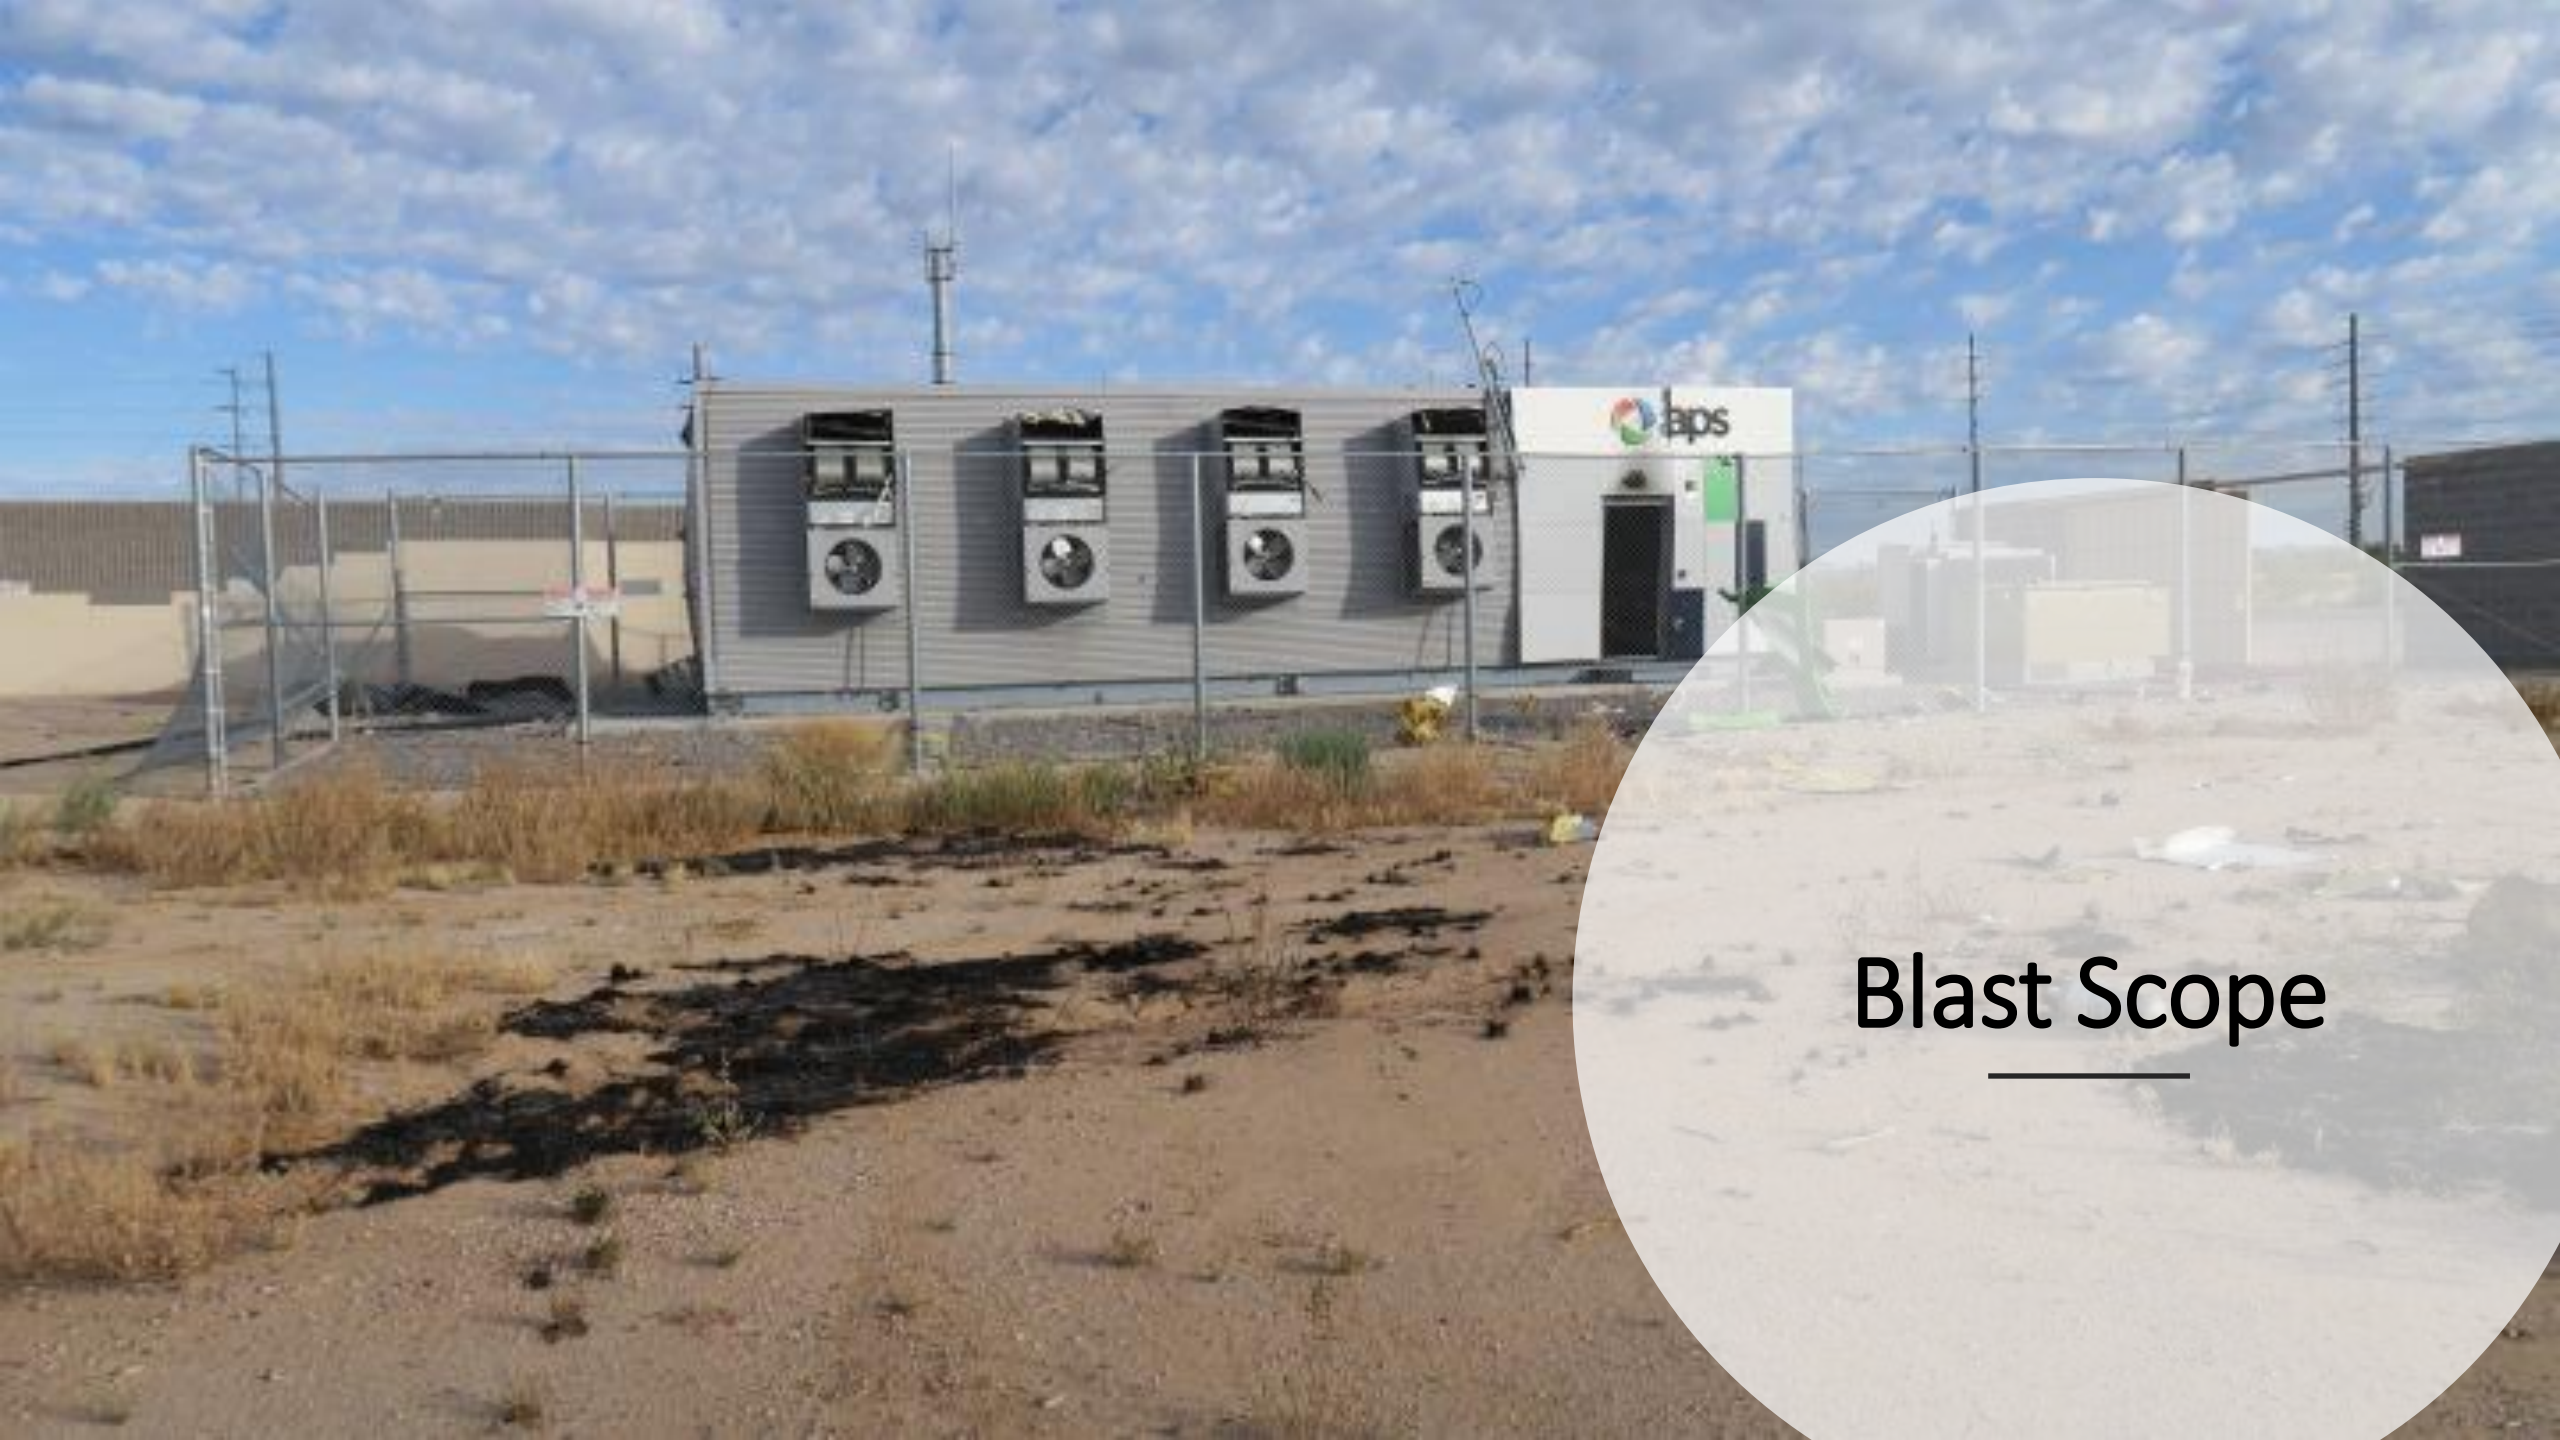
Door Hits Nozzleman

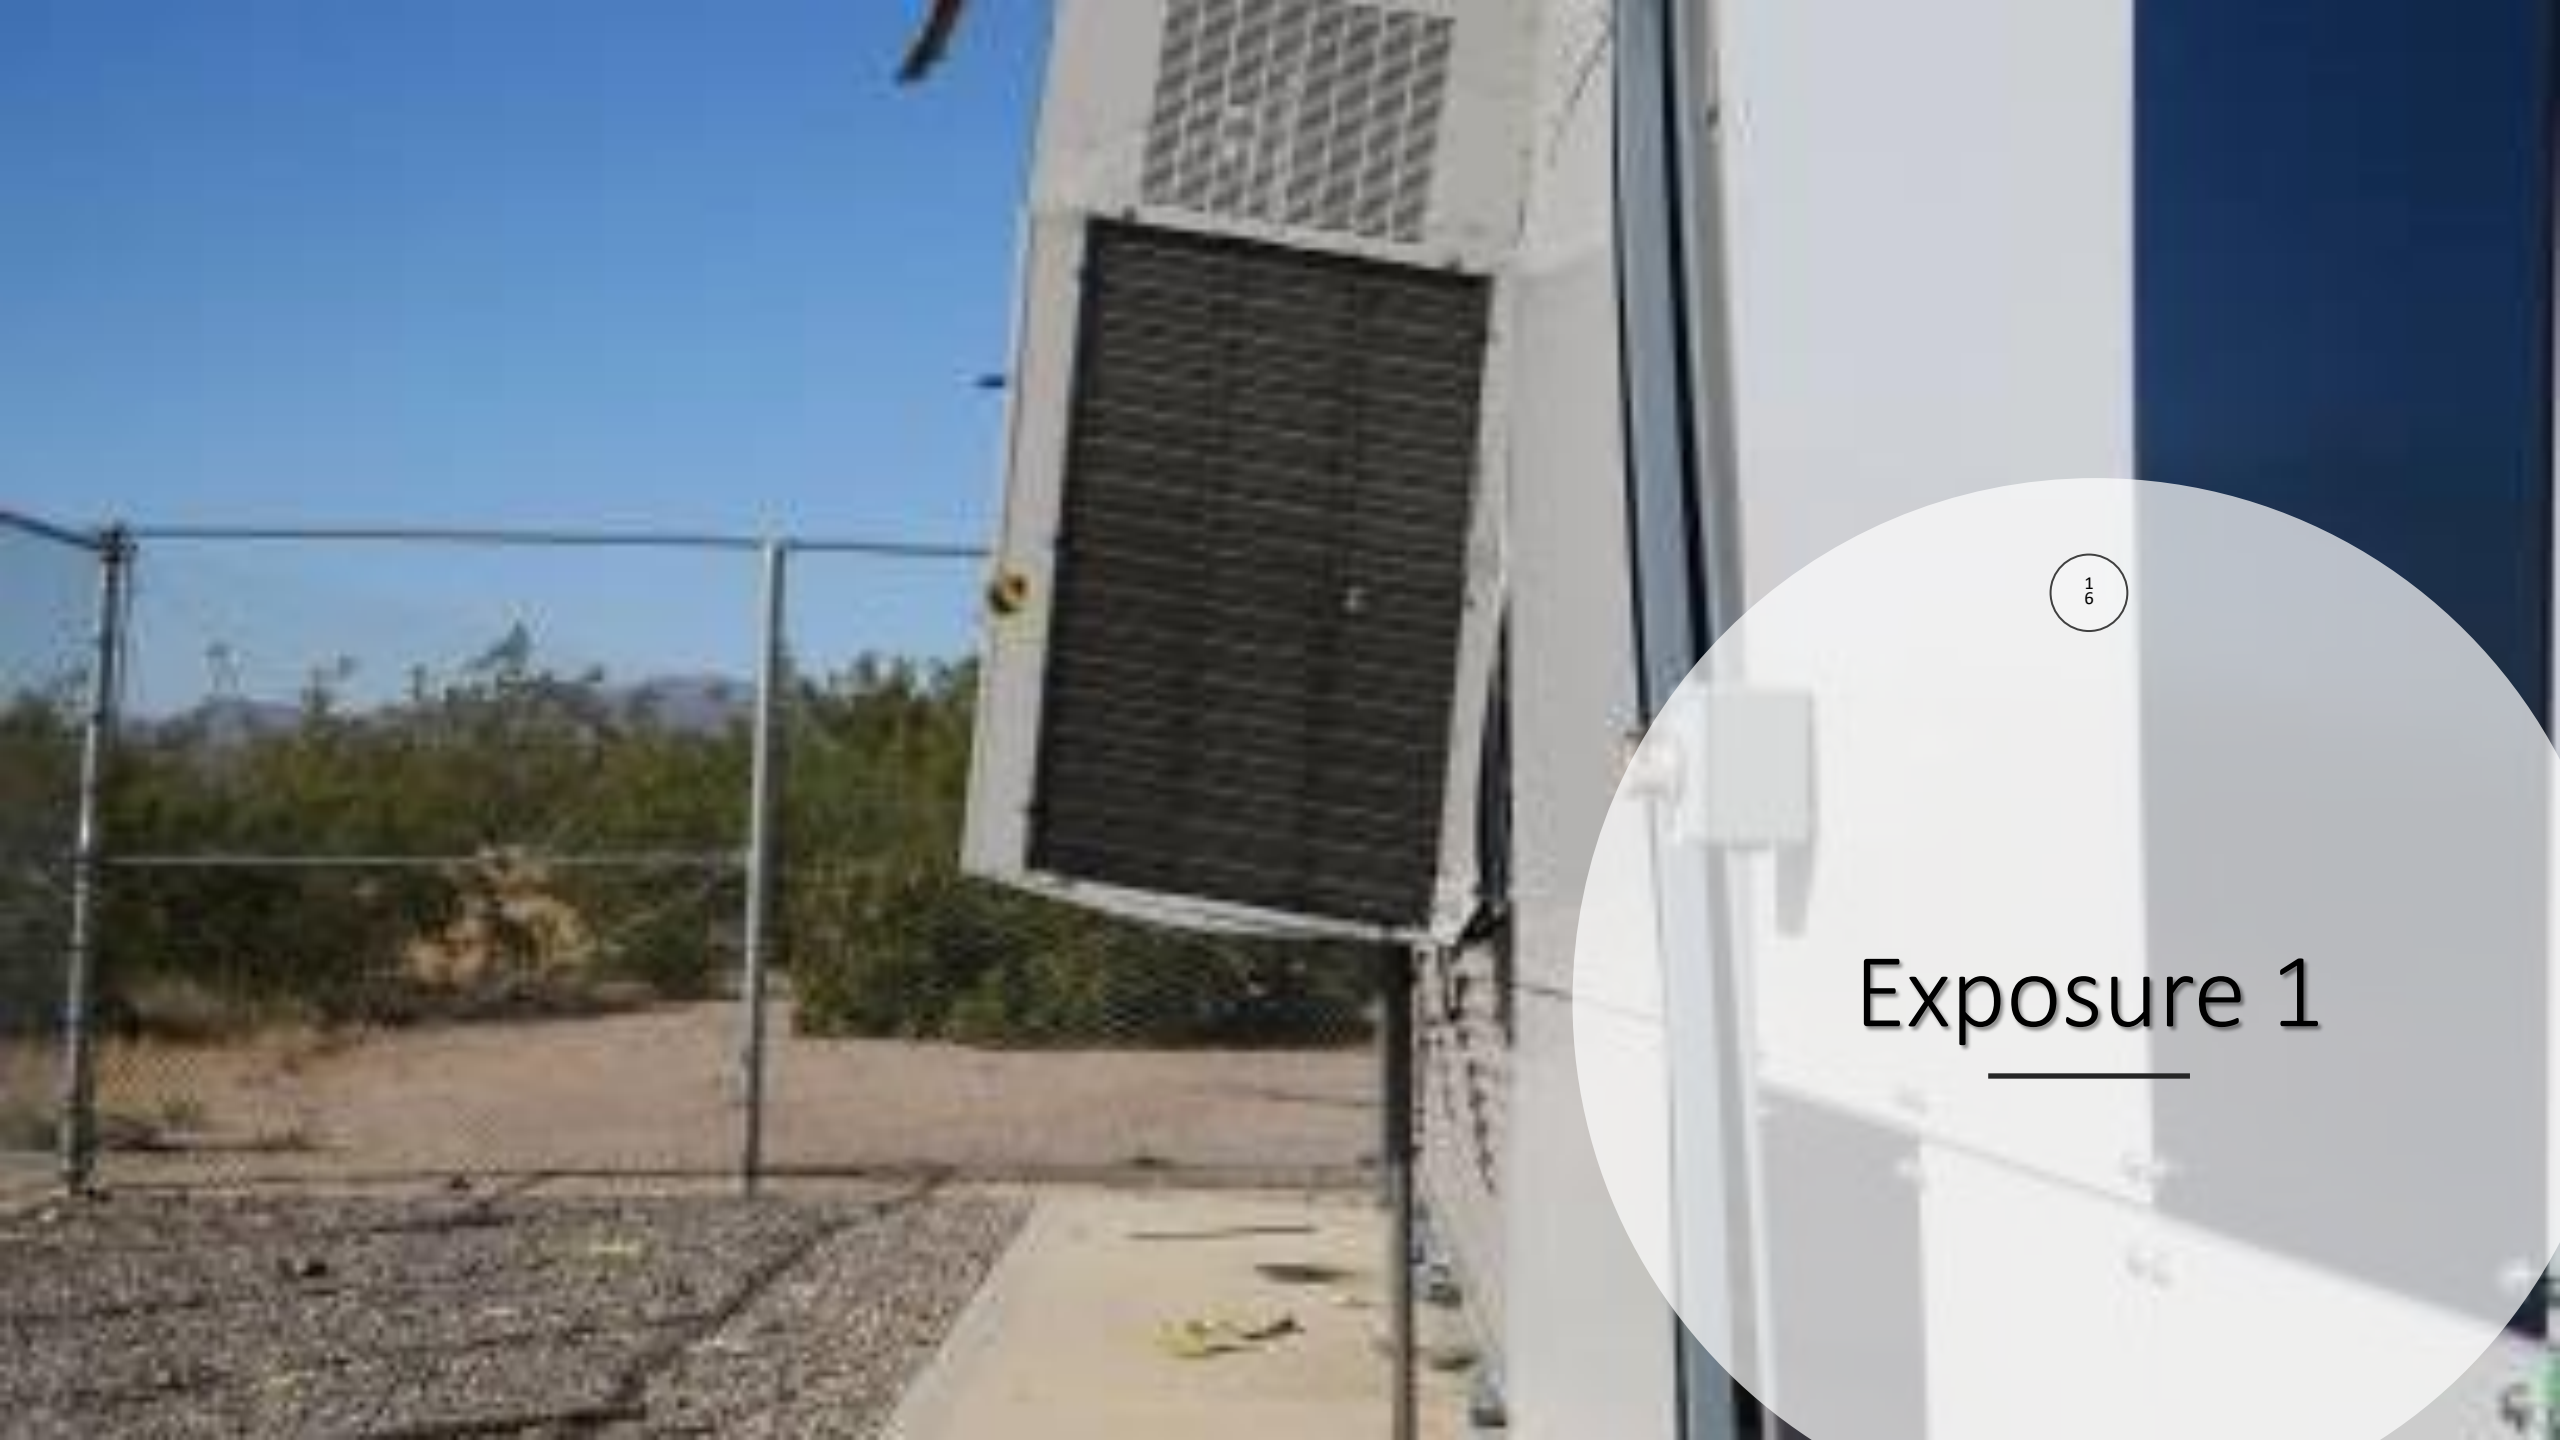
**Blast Scope**

Blast Wave  
*Carries Officer 75 Feet*

PPE Ripped Off  
*Helmets Face-  
Pieces SCBA's*

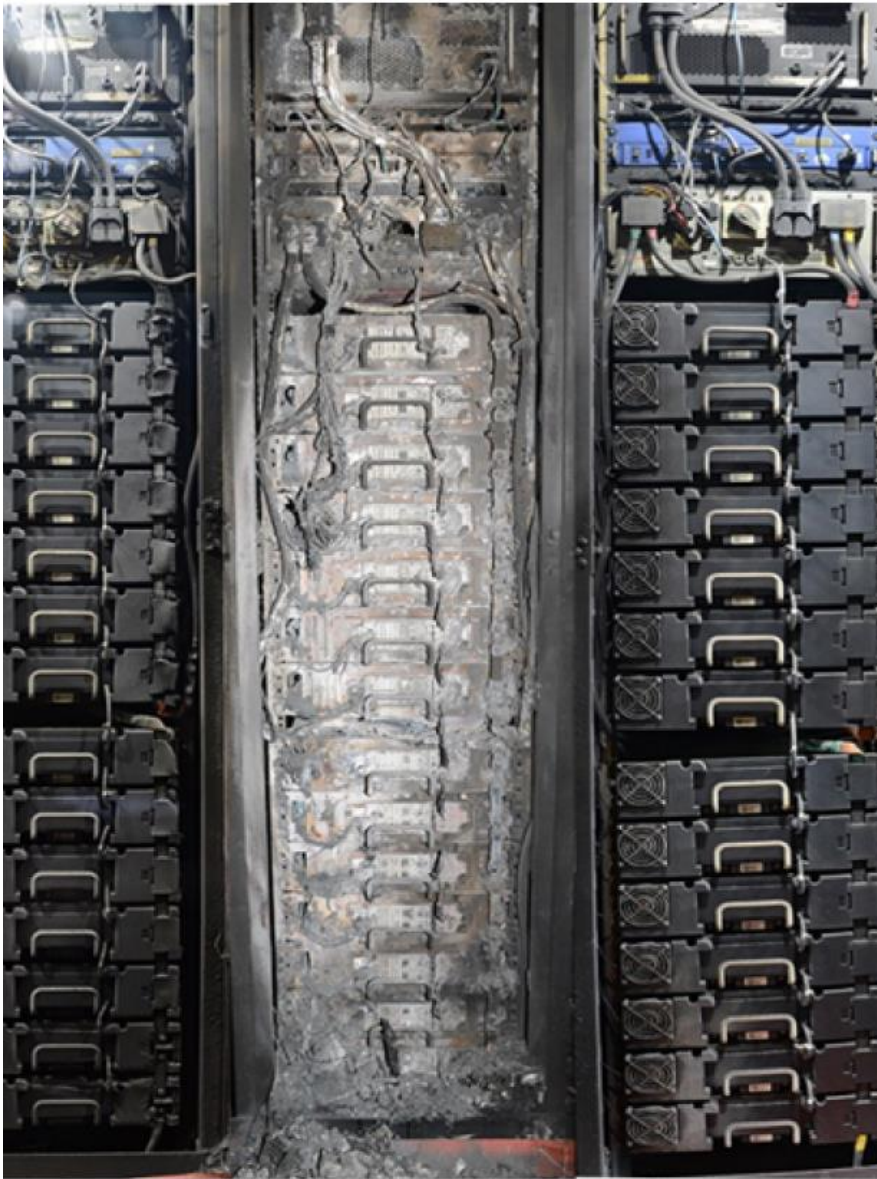
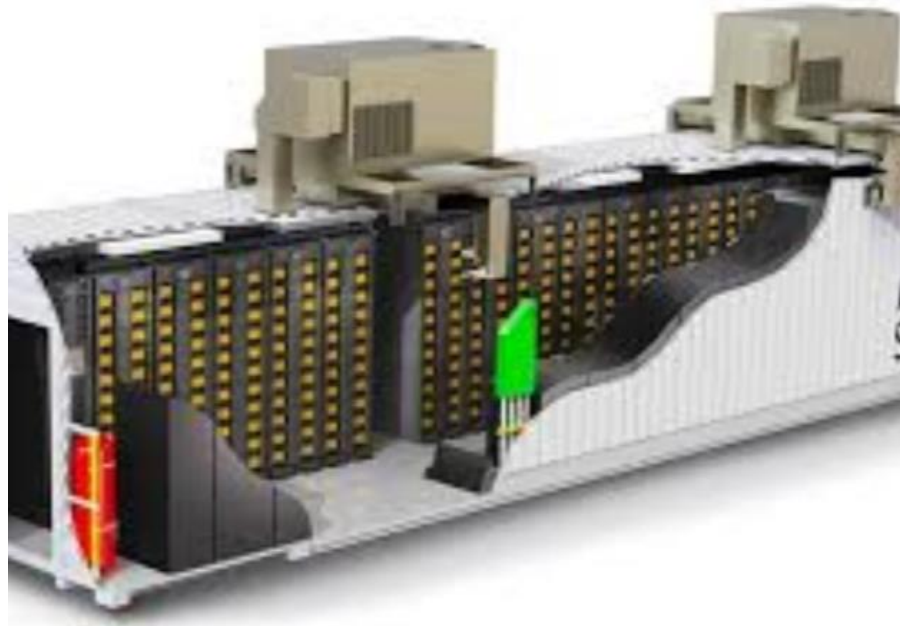
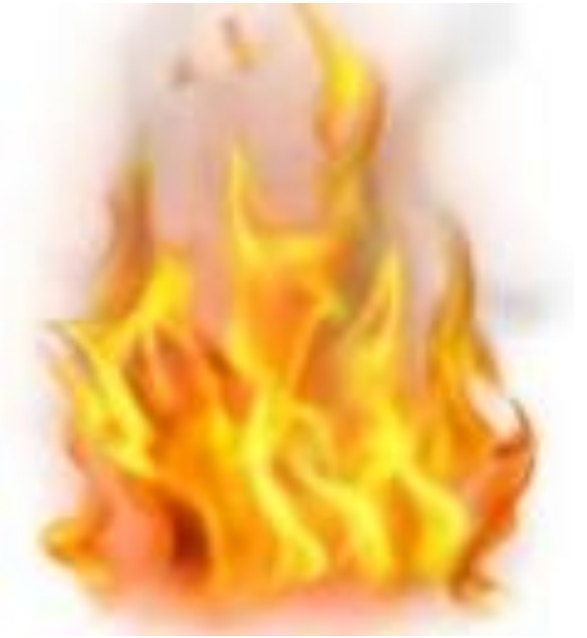
# Exposure 3

Rack 17    Rack 15    Rack 13

# Vertical Cascade
