2023 Southwest Utah Disturbance

Southwestern Utah: April 10, 2023
Joint NERC and WECC Staff Report

August 2023

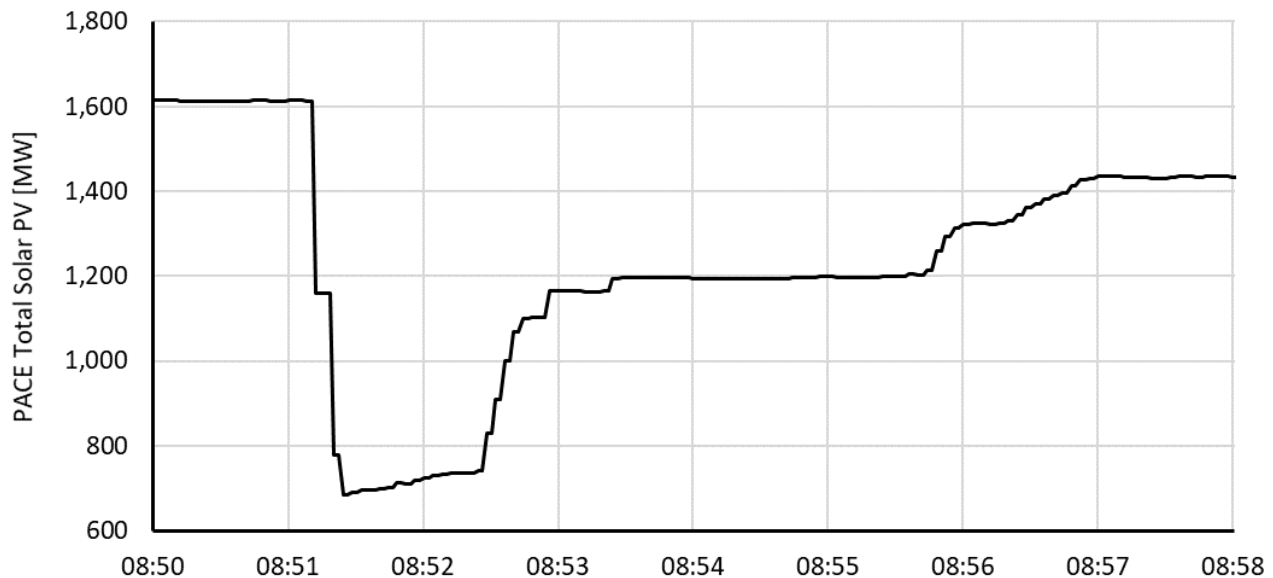
Figure I.2: PACE BPS-Connected Solar PV during Disturbance

At 08:51 Pacific time, a single-line-to-ground fault occurred on a 345 kV transmission circuit in the Southern Nevada/Southwest Utah area. Protective relaying cleared the fault normally in 3.5 cycles.⁸ While no generation tripped consequentially due to the transmission line outage, PACE supervisory control and data acquisition (SCADA) data⁹ shows that aggregate solar PV output in the PACE footprint dropped significantly (see [Figure I.2](#)). All affected solar PV facilities are located in the Southwest Utah area (see [Figure I.3](#)). The abnormal response from multiple facilities was caused by the protection and controls within each facility responding to the BPS fault in an unreliable manner. The loss of generation caused system frequency to fall from around 60.01 Hz to 59.89 Hz (see [Figure I.4](#)).

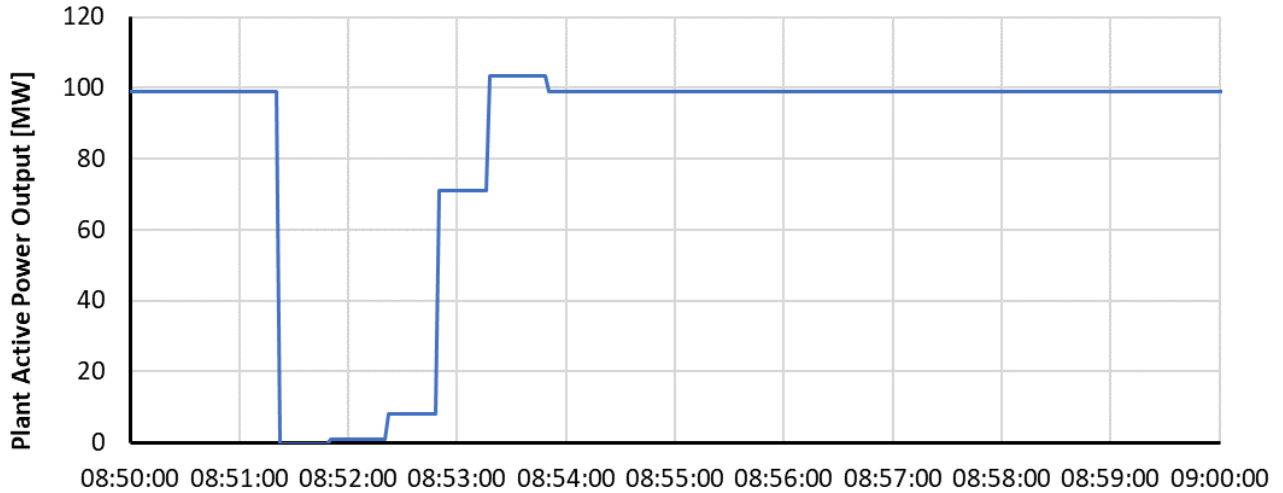
Figure A.1: Plant Active Power at POI

Plant A reduced output by 99 MW during the event (see [Figure A.1](#)). All inverters at the facility tripped on instantaneous ac overcurrent protection. The plant had no high resolution data available and did not capture any inverter-level oscillography data to analyze the tripping further.

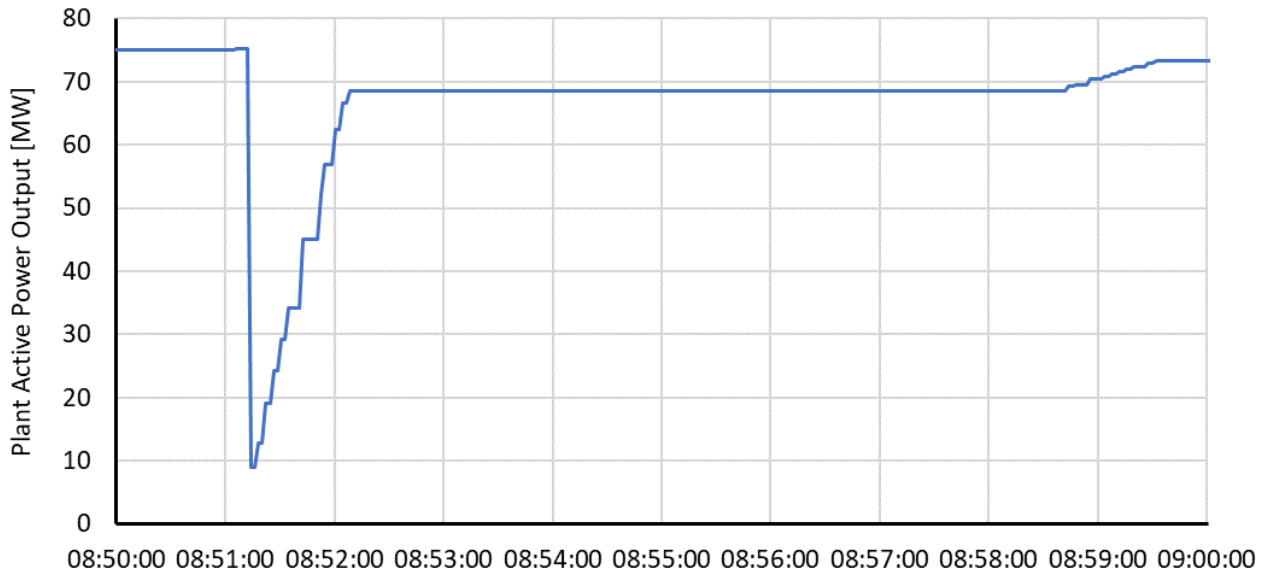
Figure A.2: Plant Active Power at POI

Plant B reduced output by 66 MW during the event (see [Figure A.2](#)). The facility owner was unable to identify the cause of reduction. The plant owner was able to identify that two inverters tripped (cause undetermined) but could not determine the cause of the other abnormal reduction and delayed recovery.

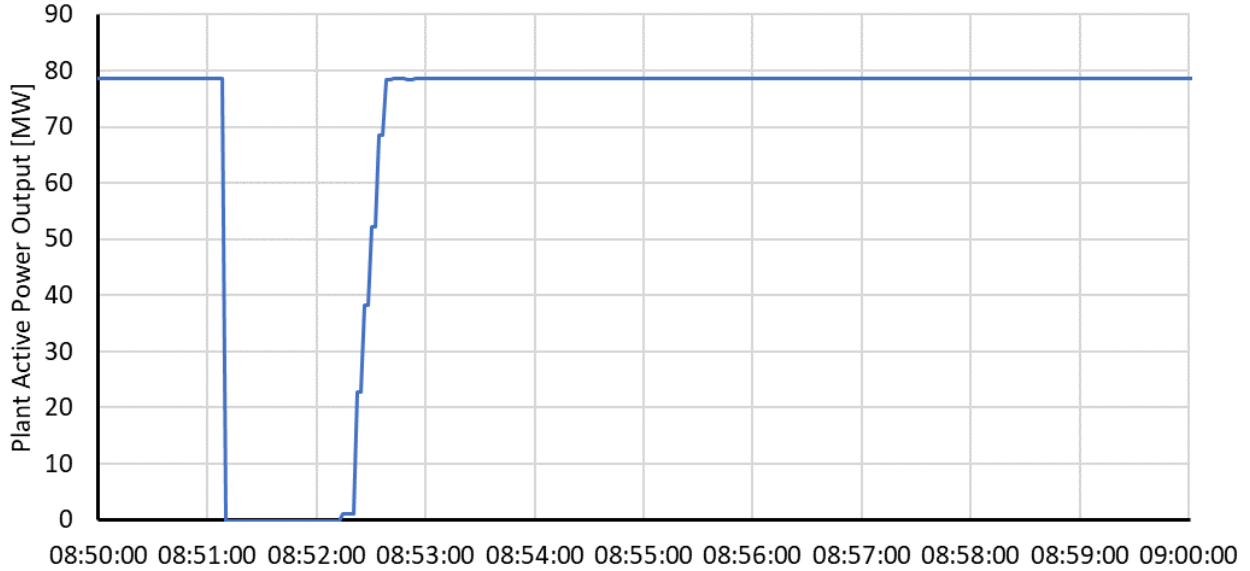
Figure A.5: Plant Active Power at POI

Plant E reduced output by 79 MW during the event (see [Figure A.5](#)). All inverters at the facility tripped. The inverters recorded fault codes for instantaneous ac overvoltage above 125% and phase lock loop loss of synchronism. The plant had no high resolution data available and did not capture any inverter-level oscillography data to analyze the tripping further.

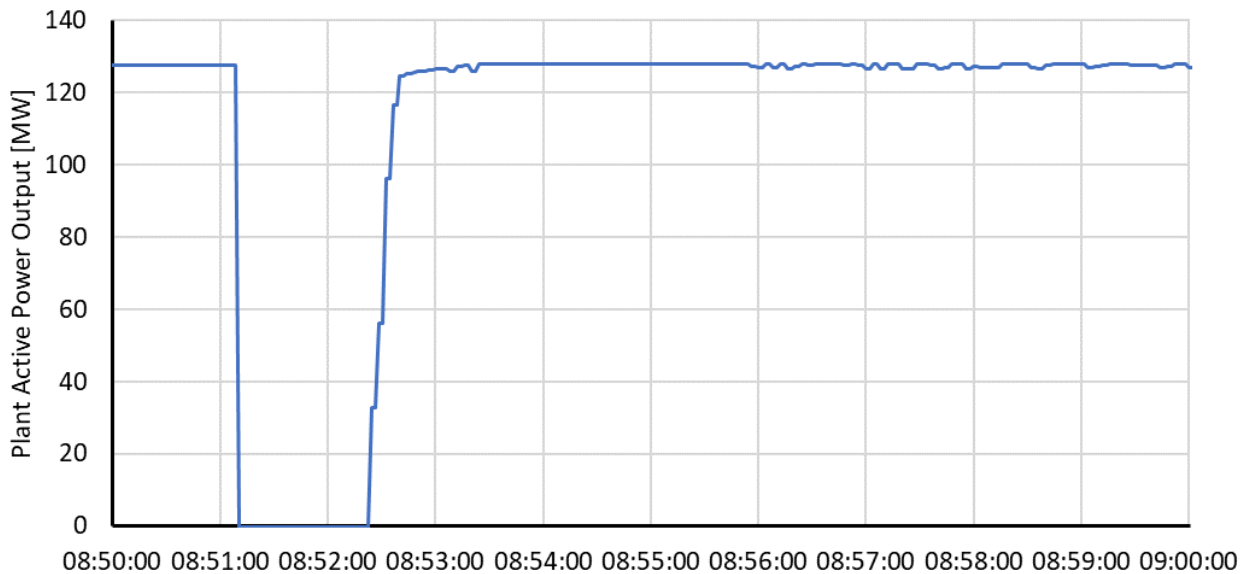
Figure A.6: Plant Active Power at POI

Plant F reduced output by 128 MW during the event (see [Figure A.6](#)). All inverters at the facility tripped. The inverters recorded fault codes involving instantaneous ac overvoltage above 125% and phase lock loop loss of synchronism. The plant had no high resolution data available and did not capture any inverter-level oscillography data to analyze the tripping further.

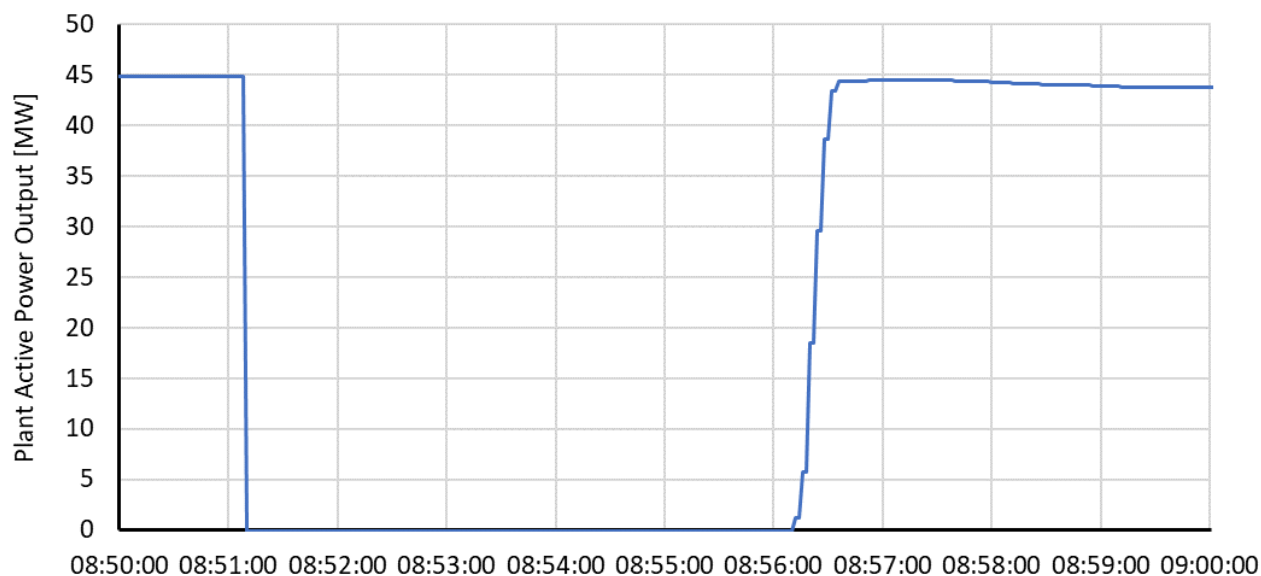
Figure A.7: Plant Active Power at POI

Plant G reduced output by 45 MW during the event (see [Figure A.7](#)). The GO was unable to identify the cause of reduction.

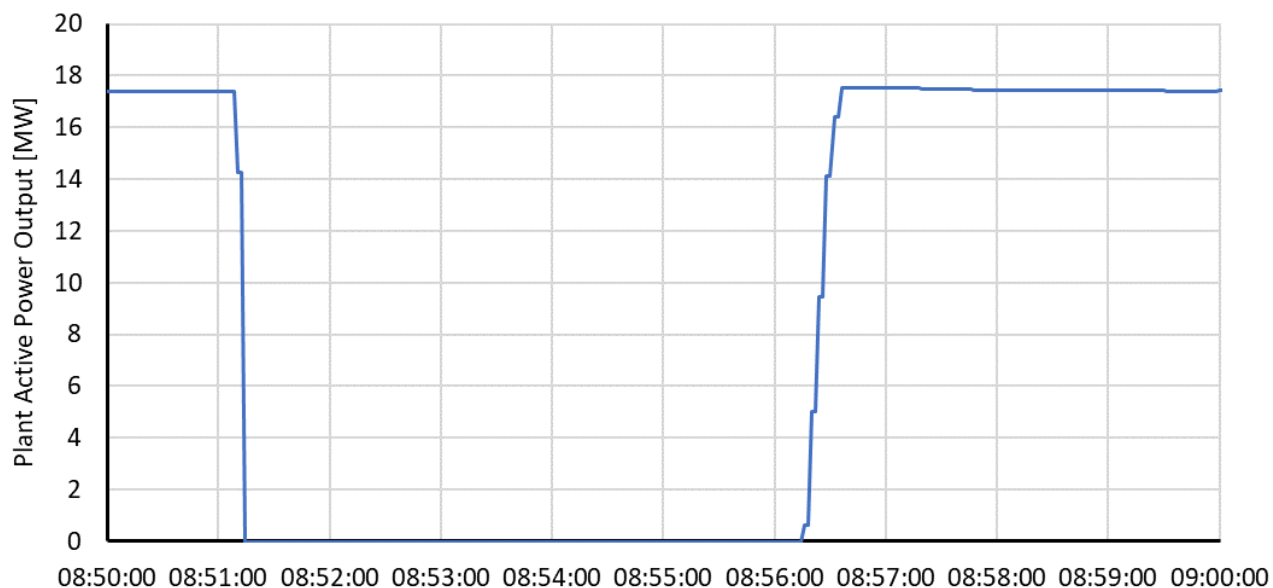
Plant H reduced output by 17 MW during the event (see [Figure A.8](#)). All inverters at the facility tripped on phase lock loop loss of synchronism. The protection was set with a voltage phase jump anti-islanding detection of 15 degrees within 500 ms.

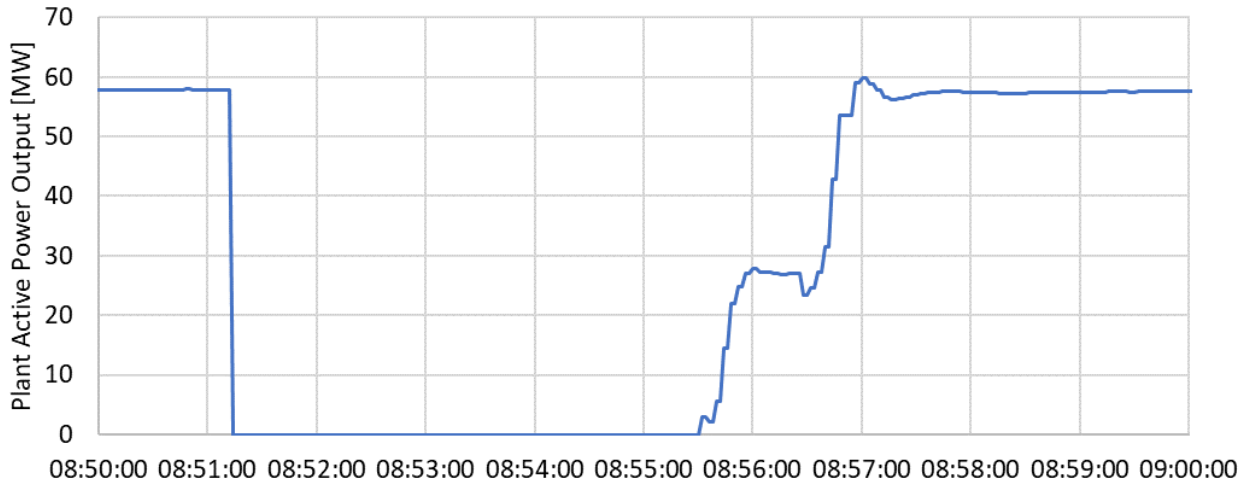
Figure A.9: Plant Unit 1 Active Power at POI

Plant I reduced output by 174 MW during the event (see [Figure A.9](#) and [Figure A.10](#)). Nearly all inverters at the facility tripped with fault codes indicating passive anti-islanding and ac overcurrent protection operating.

The GO identified that the low and high voltage ride-through “switch” parameters were disabled in all but two of their inverters, ultimately resulting in the unexpected tripping. The inverters with the setting enabled rode through the disturbance although they did enter momentary cessation due to these settings.

The GO also shared that they had proactively reached out to the inverter manufacturer for corrective actions. The inverter manufacturer focused primarily on IEEE 1547 standard requirements (particularly for disabling anti-islanding), which is an incorrect application of a distribution-centric standard to the bulk power system. The GO stated that they will be enabling LVRT with a “K-factor” of 2 to support ride-through performance.
