2023 Southwest Utah Disturbance

Southwestern Utah: April 10, 2023
Joint NERC and WECC Staff Report

August 2023

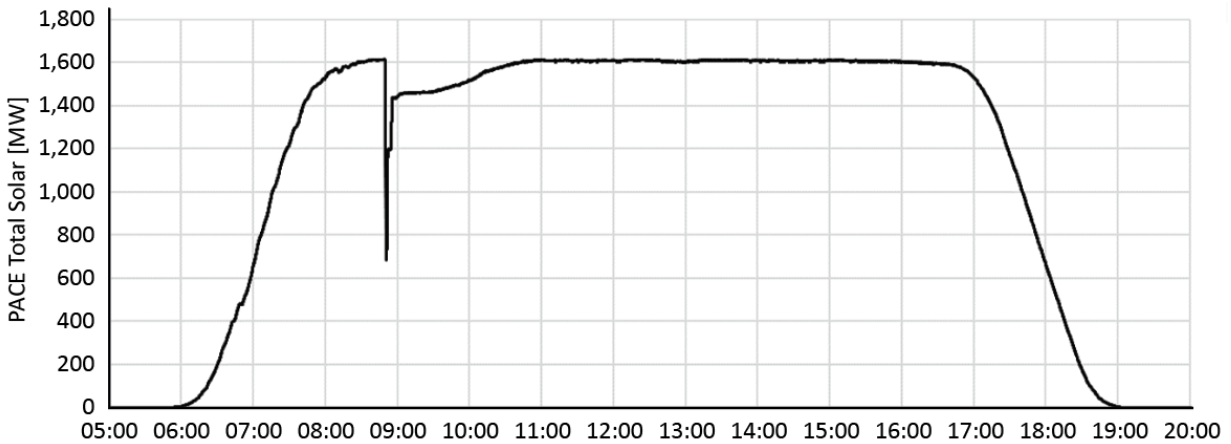
Figure I.1: PACE Solar PV Profile for April 10, 2023

Figure I.1 shows the total PACE solar PV profile for April 10. The disturbance occurred at 08:51 a.m. Pacific time, right about the time when aggregate solar PV output reached its peak for the day. Synchronous generation, wind, and solar PV resources comprised 42%, 31%, and 26% of total generation prior to the disturbance, respectively (see **Table I.1**).

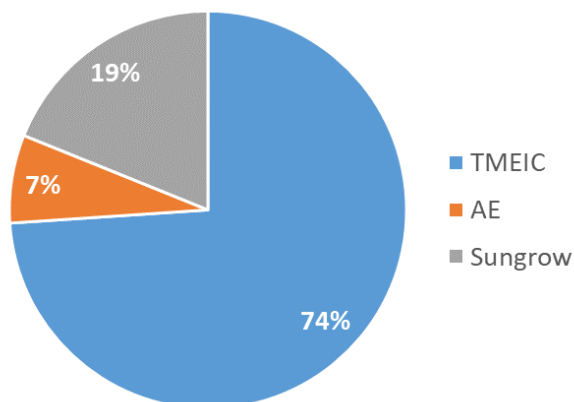
Figure 1.1: Share of Inverter OEMs at Affected Solar PV Facilities

The causes of abnormal active power reduction for each facility is listed in [Table 1.1](#), and [Figure 1.1](#) shows the inverter OEMs involved in this event. Multiple facilities tripped for several reasons, making attribution of active power reductions to specific causes difficult. Technical details are omitted in this report since the causes of reduction have been well-documented in past disturbance reports.¹⁰ The following are brief descriptions of the causes of tripping:
